INCREASING THE PERFORMANCE OF TURBOCOMPRESSORS OF MOBILE ENERGY VEHICLES

СПЕЦИФІКА КОНСТРУКЦІЇ І РОБОТИ ТРАКТОРІВ БРЕНДУ «НЬЮ ХОЛЛАНД»

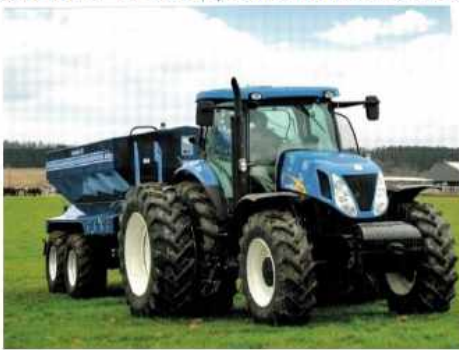
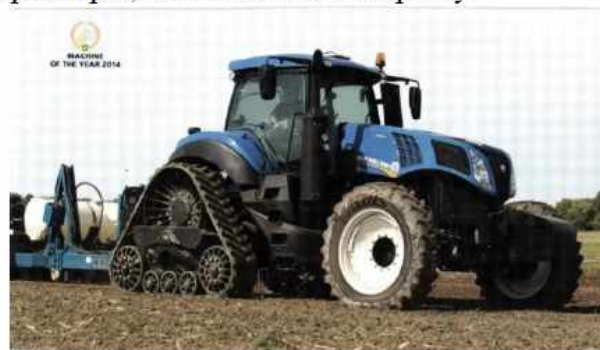
Рис 1. Трактор колісний та напівгусеничний New Holland

Побачивши успіх не дуже потужного МТЗ (80-100 к.с.) на вітчизняних полях, концерн CNH вирішив вивести новий трактор на наш ринок. Голландії приблизно з такою ж потужністю (рис. 1). Моделі TL 5040, TL 5050, TL 5060 також мають двигуни потужністю 80-100 к.с., і такі машини за виробничими параметрами підходять багатьом аграріям, в тому числі і Україні. Однак ціни на них вищі, ніж у Білорусі, що серйозно впливає на вибір аграріїв. Вузкий і округлий капот, характерний для нових голландських тракторів, забезпечує хорошу маневреність навіть під час складних «танців» з фронтальним навантажувачем. Кабіни тракторів серії TL5000 оснащені скляними дверима та збільшеними вікнами (бокові та задні вікна, що відкриваються). Великі прозорі поверхні та тонкі колони демонструють круглу форму фронту роботи. Рівень шуму в салоні не перевищує 79 дБ [1].
